Analysis of landing accidents

appendix III

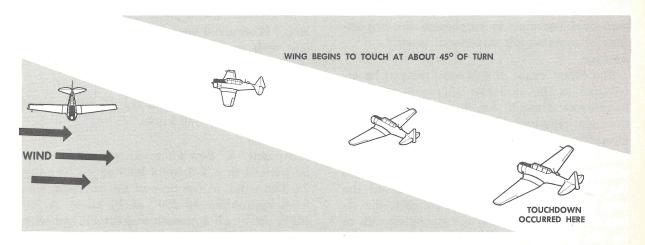
Accident No. 1

After the touch-down the aircraft started a slow turn to the left. The student failed to apply corrective action to maintain directional control and, as a result, the aircraft started turning to the left very rapidly. During the turn the right wing tip struck the ground. After approximately 180° of turn the aircraft was brought to a stop.

That damage was inflicted to the right wing tip and ailerons and that total estimated cost of the accident was \$76.92.

From the above evidence it is concluded that the primary cause factor in this accident was the failure to use the flight controls and power to maintain directional control.

The direct cause of this accident can be attributed to the student's failure to maintain directional control. As the aircraft entered the turn, centrifugal force began acting on the aircraft's center of gravity outward and away from the direction of turn. As you know, the effect of centrifugal force is proportionate to the speed of the turning moment. Since the turn was allowed to increase steadily, the effect of centrifugal force was strong enough to tip the aircraft to such an extent that the right wing tip struck the ground.

It is recommended that all students be briefed on this accident and that supervisory personnel continue to emphasize the importance of maintaining directional control.

This accident could have been averted if the student had used right rudder and/or brake in the early part of the turn. A power application would also have been very helpful. He could have very easily applied full power and executed a go-around. Even after the aircraft had lost most of its flying speed and the swerve had become very sharp, the judicious use of right brake (low wing-tip side) and throttle would have stopped the turn. Rudder is not very effective in stopping a very sharp turn at low speeds because the airflow around the vertical stabilizer is not very effective.

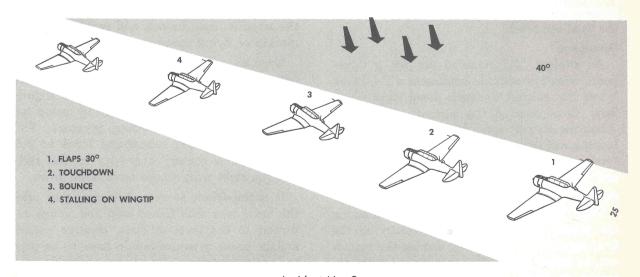
Accident No. 2

When the aircraft struck the runway, the student pulled the stick back, and thus aggravated the bounce condition. He continued to hold the stick back and established an extremely nose-high attitude even though the aircraft was undergoing a severe bounce. The aircraft stalled and the left wing dropped. Power, right rudder, and right aileron were applied as corrective action. This corrective action was inadequate and the left wing tip struck the ground at approximately the same time as did the left landing gear.

That damage was inflicted to the left wing tip and aileron and that the total estimated cost of the accident was \$62.18.

It is concluded from the above evidence that the primary cause factor in this accident was an improper recovery from a bounce, coupled with the student's slowness in applying corrective action once the wing started to drop.

This student exercised poor judgment and improper bounce recovery technique, probably as a result of being tense. The student allowed the aircraft to touch down before a three-point attitude was attained. When the aircraft landed main gear first, he pulled the stick back for no apparent reason, other than perhaps a mechanical response. This, of course, only aggravated the bounce condition and caused it to be much more severe than it otherwise would have been.

It is recommended that all pilots be again reminded that a go-around is the only safe and

positive recovery from a bad bounce.

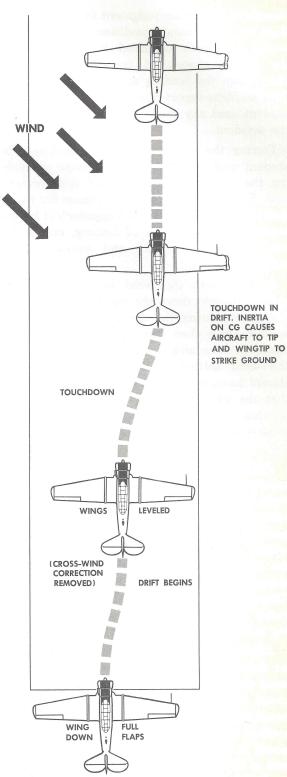
Accident No. 3

A landing was effected in a three-point attitude. The right wing tip scraped the runway after the aircraft had rolled approximately 75 feet down the runway. The aircraft was brought to a stop just off the right edge of the runway approximately 100 yards from the point where the accident occurred.

That the right wing tip, aileron, and wing section were extensively damaged and that the total estimated cost of the accident was \$432.12.

It is concluded from the above evidence that the primary cause factor in this accident was the failure of the student to maintain a crosswind correction throughout the touch-down and landing roll. This was aggravated by the use of full flaps in a gusty cross-wind landing.

During the round-out for the landing, the student made the inexcusable mistake of leveling the wings and removing all drift correction. There was absolutely no reason for using drift correction on the final approach if he intended removing it before landing, unless the wind condition changed and warranted the wings being level.

What could have been done to avert an accident under these conditions? In the first place, the drift correction should never have been removed. It should have been maintained throughout the round-out and touch-down.

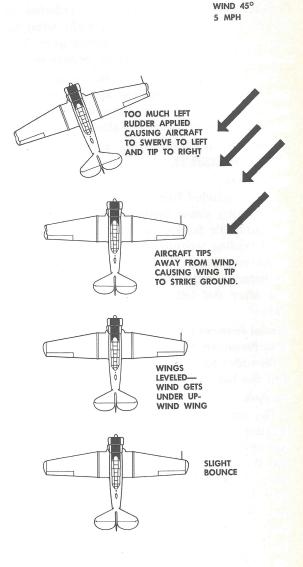
Accident No. 4

On his second attempt to land, his approach looked normal from the mobile control except that he had no correction for a slight crosswind from the right at 6 knots. Touch-down was made slightly wheels first and a skip resulted. As the aircraft again settled onto the runway, the left wing started down, allowing the wind to get under the right wing and accelerating its movement upward. Shortly afterward the left wing tip struck the runway.

turn to the left and off the runway, dragging the right wing tip and aileron. The right wing was thrown down by centrifugal force and contacted the runway, inflicting damage to the right wing tip, aileron, and right main gear.

That substantial damage was inflicted to the left wing tip and aileron, right wing tip and aileron, and the main landing gear. This necessitated a change of these components.

That as the aircraft left the runway, the tail wheel lock-pin sheared and the resultant castoring effect possibly increased the rate of turn and centrifugal force effect.

It is concluded from the above evidence that the primary cause factor in this accident was the student's failure to use the proper crosswind landing technique and failure to use adequate correction for a wing-low attitude. In addition, he failed to maintain directional control after the left wing tip struck the runway.
